TECHNICAL BULLETIN – TB039

SUBFLOOR PREPARATION – THE KEY TO SUCCESSFUL FLOORING INSTALLATIONS

Date, Wednesday, 23 May 2018

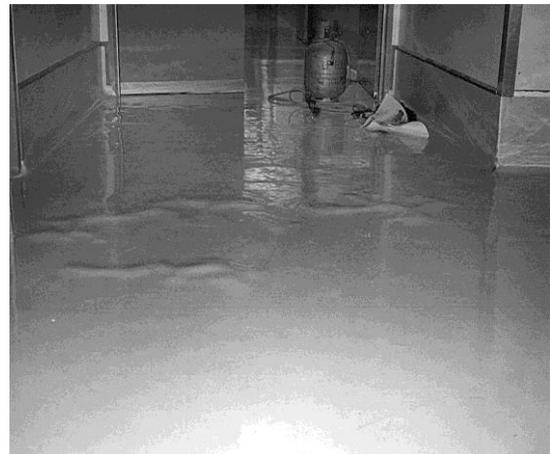
Case Study 1 - Moisture Problems

In this application the commercial vinyl was laid over a floor which had a rising damp problem. The floor was not checked initially for moisture levels and a moisture barrier was not installed.

The resulting rising moisture penetrated through the K15 leveller and was trapped beneath the vinyl, resulting in de-bonding and blistering.

The entire installation had to be removed, moisture barrier installed, and underlayment and vinyl re-instated

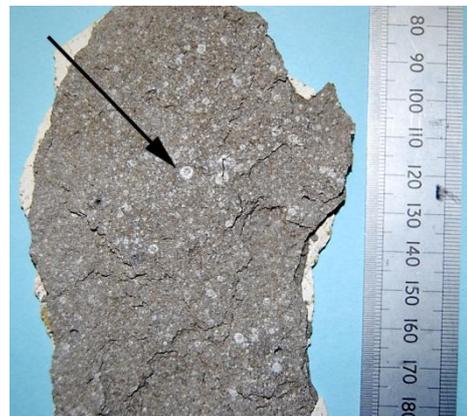
Case Study 2 - Moisture Problems causes smoothing cement to decompose

Vinyl tiles were laid over below grade old concrete floor. Ardex A55 and Ardex WPM300 were used. After approximately 18 months the floors start to erupt in large spalled areas.

Investigation of the site indicated a problem with subfloor moisture due to; below grade slab, and leaking roof. The moisture barrier was applied thick enough to prevent progressive penetration of the water.

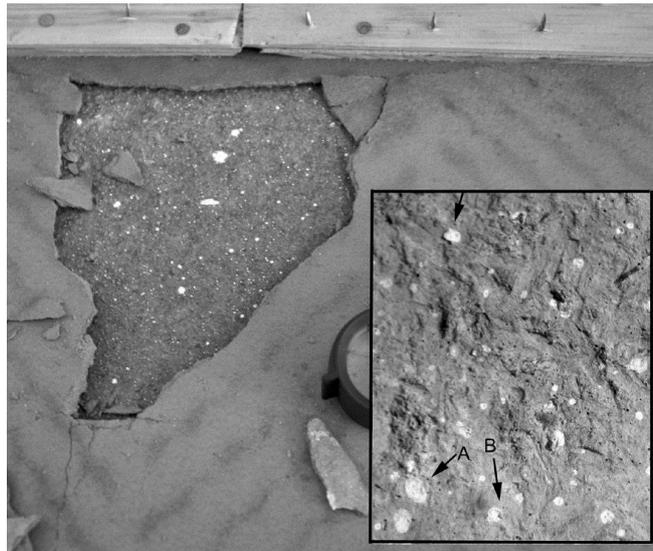
Case Study 3 – Surface contaminants and weak surface layer

A second storey renovation had a particle board floor installed which was to be overlain with carpet. The surface was flattened with Arditex. After approximately 6 years the customer noticed drummy spots under the carpet.

Investigation revealed that the subfloor was contaminated with building residue including paint or plaster (A-B). The particleboard has also been subject to water damage and the weak surface layer with the including water seal was not removed. The Arditex pulled this weak layer off the floor.

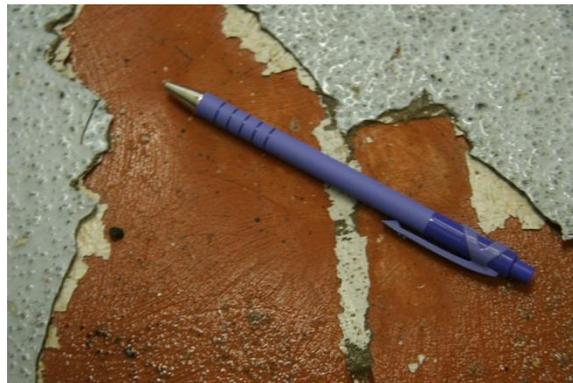
Case Study 4 – Poor surface preparation and thin moisture barrier

Smoothing cement with a coarse finish epoxy coat were applied over a smoothing cement on old terracotta tiles.

Investigation revealed that the moisture barrier was only ¼-½ of the required. The tiles also had a weak surface after grinding which de-bonded under the load the floor was subjected to. Irrespective, Ardex does not offer this system as a recommendation.

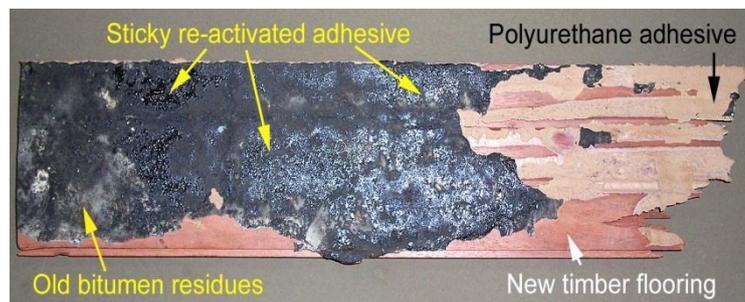
Case Study 5 – Old adhesive not removed

An old concrete floor had the vinyl removed but the old 'Black Jack' adhesive was left in place. A 1.5mm skim coat of Arditex was applied and then strip timber fixed with polyurethane adhesive. After a short time the floor de-bonded.

Analysis shows that the polyurethane adhesive contained aggressive solvents which penetrated through the wafer thin Arditex and reactivated the old adhesive which de-bonded off the floor.

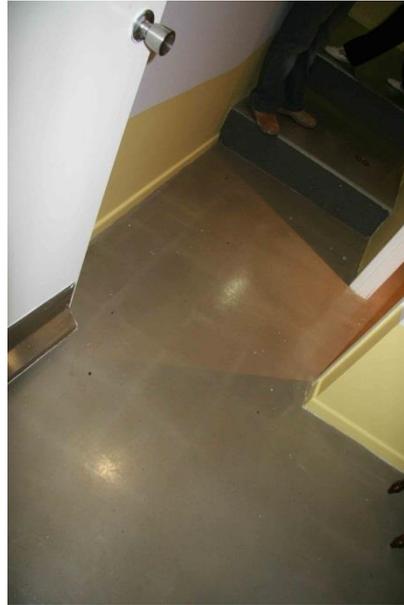
Case Study 5 – ‘Feature floor’ applied over existing tiles

A existing tiled floor in a restaurant was over coated with Ardex P82 then Ardex K12 and a sealer. The grout lines developed show through.

There was no real need to investigate this complaint as it was a non-recommended application. It occurs because the porosity differences between the grout and tiles. A similar problem can result from Feather Finish over tiles before vinyl flooring, when not enough Feather Finish is applied.

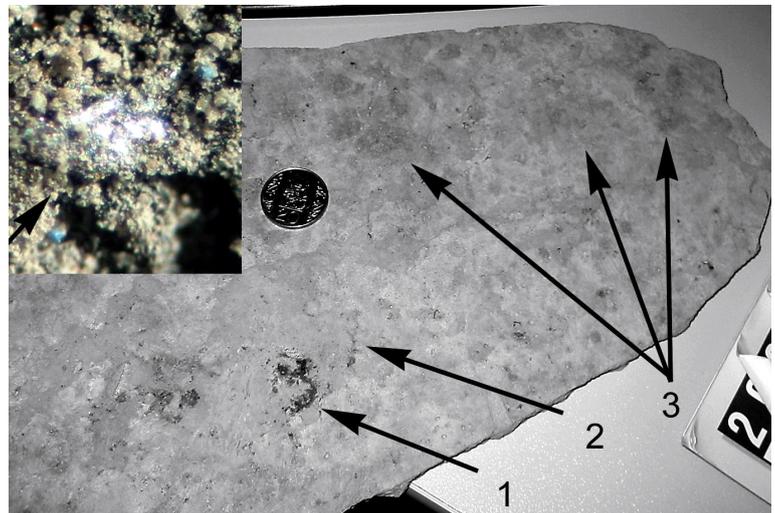
Case Study 6 – Oils and metallic residues on floor

An old aluminium foundry was floor to be used as a sporting complex was flood coated with Arditec. Sections of the floor subsequently de-bonded.

Examination of the Arditec revealed the presence of several contaminants including oil (1), old weak surface concrete (3) and metal slag (2-inset picture). These indicated the floor had not been mechanical prepared and cleaned

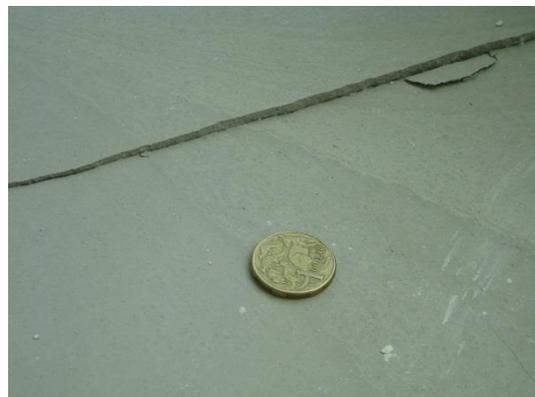
Case Study 7 – High strength concrete, moving slab and too thick product

Concrete floors in a multi-level building were smoothed up to 30mm with Ardex K12, and then cracked and de-bonded.

Examination of the floor showed it to be ground, but the topping only cracked above 12mm thick and around the building perimeter. Complex investigation revealed the slab to be post tensioned and off specialised design leading to high strains. Also the concrete was of unusual mix design. E25 polymer modified K12, and normal K15 did not crack.

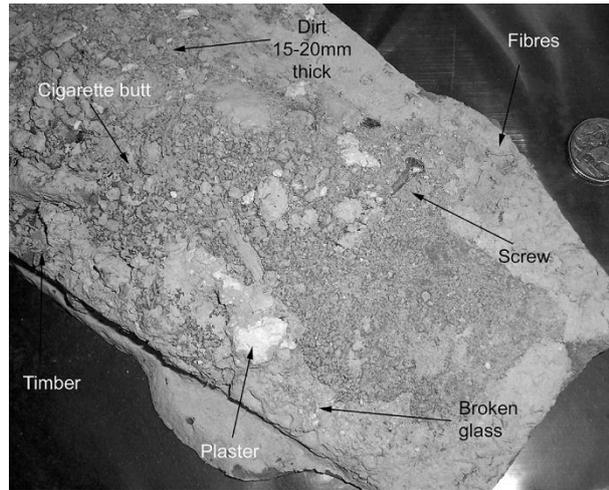
Case Study 8 – Extreme subfloor contamination.

This sample was one of the worst seen by Ardex to date.

A concrete floor has been 'filled' and 'smoothed' for tiling. Subsequently the topping cracked up and de-bonded.

The reality was that the installer had swept the building residues on the floor into the floor's low spots, and then poured 15-20mm of smoothing cement over the top!!! No attempt had been made to clean the floor at all.
