# TECHNICAL BULLETIN – TB040

## SUBFLOOR PREPARATION – SOURCES OF MOISTURE AND DAMP SLAB PROBLEMS

Date, Thursday, 24 May 2018

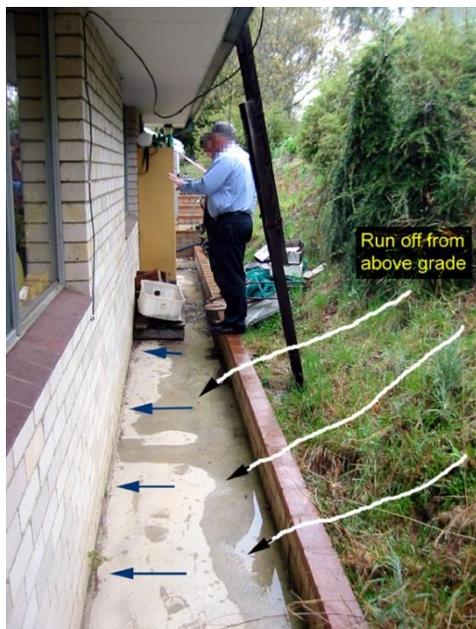
Figure 5

The site shown is a dwelling with a below grade slab which was subject to a moisture complaint.

Water due to surface run off onto the slab, and also percolating ground water in through the base and edges have penetrated the slab and resulted in high moisture contents in the concrete inside the building.

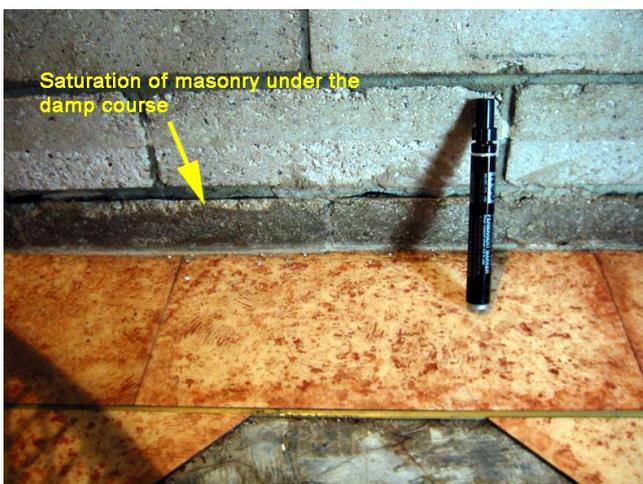
Figure 6

What was found inside the building? As can be seen the masonry below the damp course was saturated with moisture.

A vinyl installation was put in place without a membrane and suffered de-bonding due to rising damp.

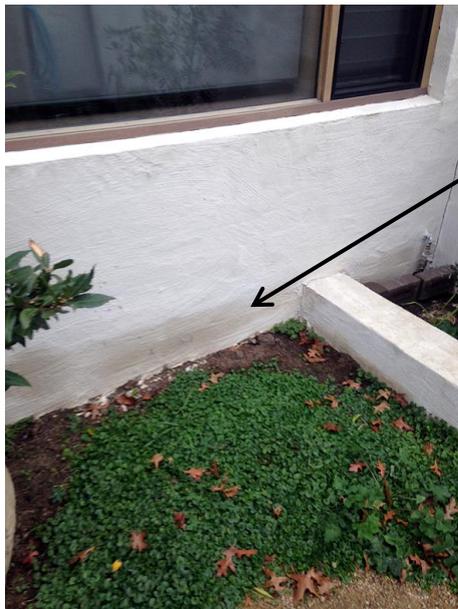
Figure 7

An example of a raised garden bed creating dampness in a wall, which then transferred through the masonry into the subfloor.
