## TECHNICAL BULLETIN – TB112

### PEBBLECRETE AND MARBLESHEEN

Date: Thursday April 2<sup>nd</sup> 2020

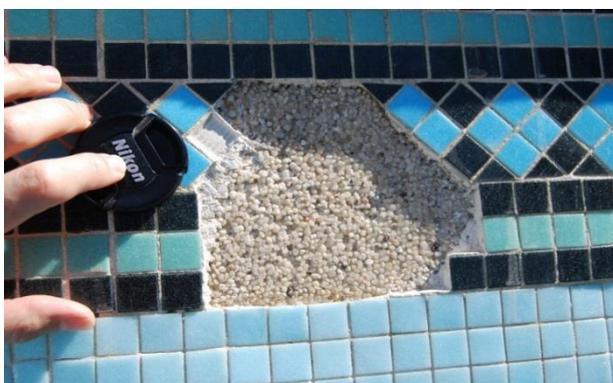
Adhering levelling compounds, tile adhesives or membranes to a surface requires that surface to be stable, well bonded and usually porous. Older 'Pebblecrete' surfaces can be poorly bonded which means that the surface can lift and break away, taking the overlying surface with it. Levelling compounds can develop a degree of tension during curing and tile systems tend to move with changes in temperature and wetness. These stresses can also affect the bond of 'Pebblecrete' to the substrate.

There can also be issues with adhesion to 'Pebblecrete' with regards to the binder, sealers and nature of the aggregate. Sealers can act as release agents which can lead to the applied material de-bonding. Resin rich epoxies can be difficult to bond to due to the surface properties and chemical inertness. Weathering can also lead to chalkiness in the epoxy which provides a weak layer. Highly polished and smooth river aggregates provide a non-porous surface which is not ideal for bonding to.

An example of a pool shell where tiles were applied over 'Pebblecrete' with generally poor adhesion of the tile adhesive.

ARDEX recommends the best way of dealing with 'Pebblecrete' surfaces prior to the application of levelling cements, ceramic tile adhesives and membranes is to **remove the material** from the surface via mechanical methods.

Mechanical methods includes diamond grinding scabbling, scarifying, shot or grit blasting back to open porous concrete. The reason for this approach is that it removes any uncertainty as to the type or stability of the 'Pebblecrete' and marble render, and eliminates adhesive bond/compatibility issues.
